Manhole Inspection Summary

Manhole # S35U__038MH

Insp Date: **3/20/08 2:48 PM**

Location Address: **1400 marshall**

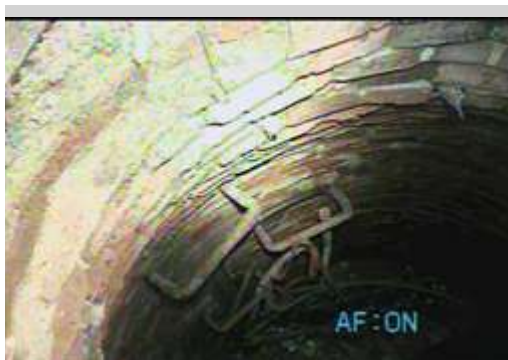
Defect 2

corroded steps, debris

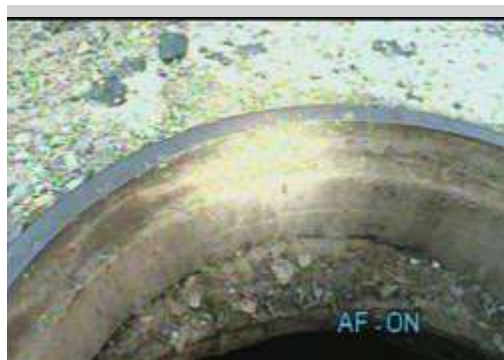
Defect 1

Frame Offset: **4** (in.) Condition: ☒ Sound ☐ Cracked ☐ Leaks

offset
